**Department of Public Works
Heavy Equipment and Related Parts
Inventory Management**

**Performance Audit
October 1, 2012 through September 30, 2016**

**OPA Report No. 17-04
September 2017**

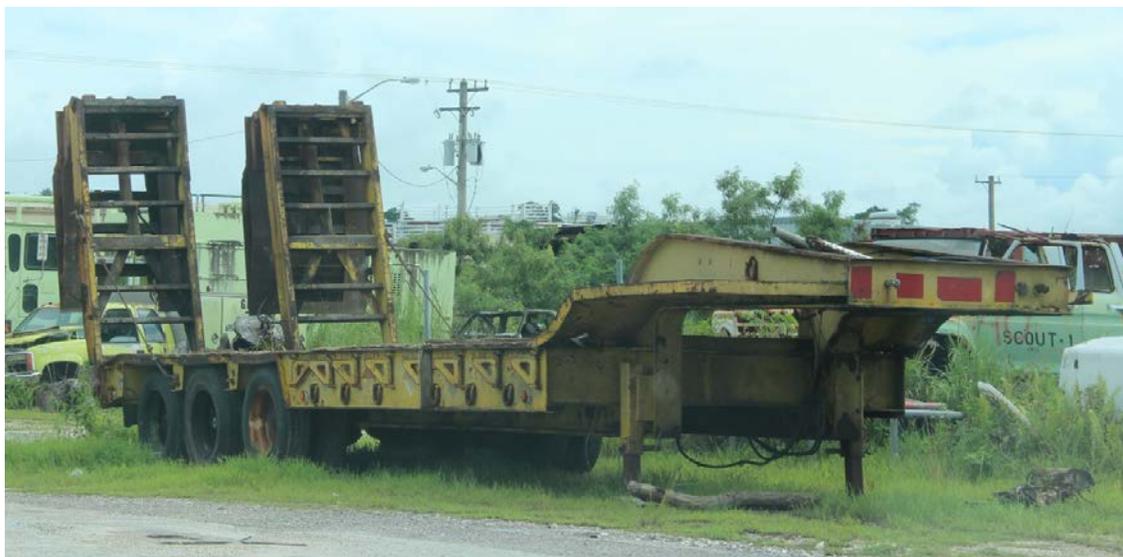
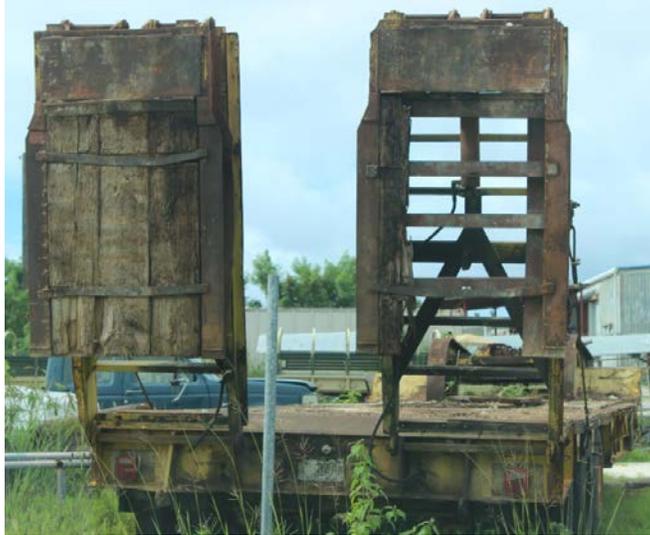
The lowboy was allegedly missing for an undetermined number of years and DPW alternatively rented lowboy trailers. DPW management claimed the lowboy had been in poor condition stored on the DPW lot and covered in trash. However, we found maintenance cards documenting repairs for the unit in December 2009, and over four years later, a hydraulic repair (SRO#14-0449) in February 2014, and a battery replacement (SRO# 16-41) in October 2015.

Following OPA’s inquiries about the lowboy’s whereabouts with DPW staff, the lowboy was returned and we observed it on the DPW compound on September 23, 2016 and in poor condition (Images 1 and 2). In November 2016, the lowboy was repaired and repainted and used in a DPW project.

Image 1: Lowboy - side view (license plate #2271) seen on September 23, 2016 before repairs.

Image 2: Lowboy - rear view (license plate #2271) seen on September 23, 2016 before repairs.

Despite the lowboy's return to DPW, we recommend that DPW management investigate how the lowboy was allowed to go missing for an undetermined number of years.

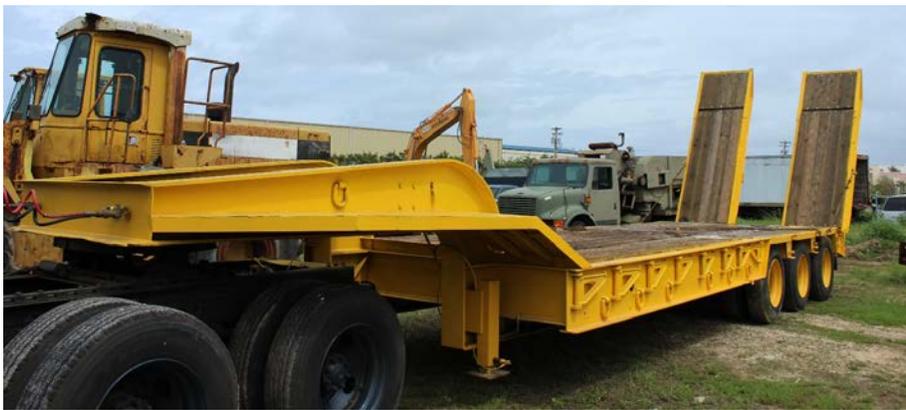
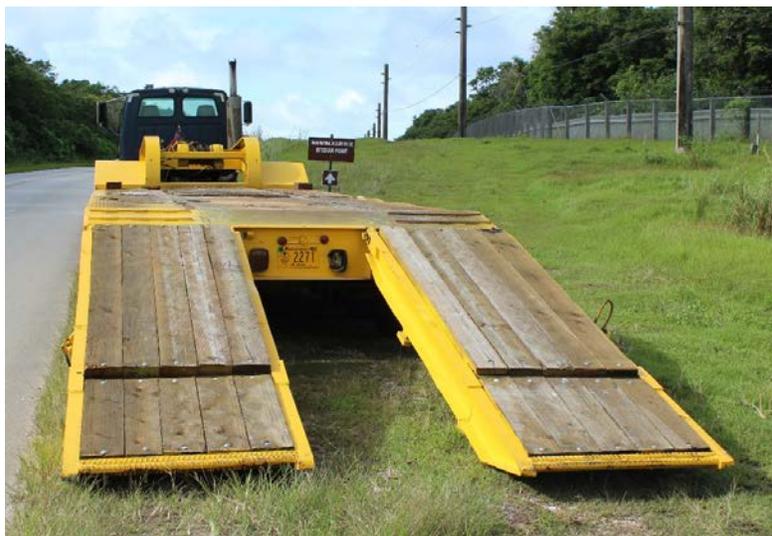
Image 3: Lowboy - side view (license plate #2271) seen on November 4, 2016 at the DPW Heavy Shop after repairs.

Image 4: Lowboy - rear view (license plate #2271) seen on November 14, 2016 at a work site after repairs.

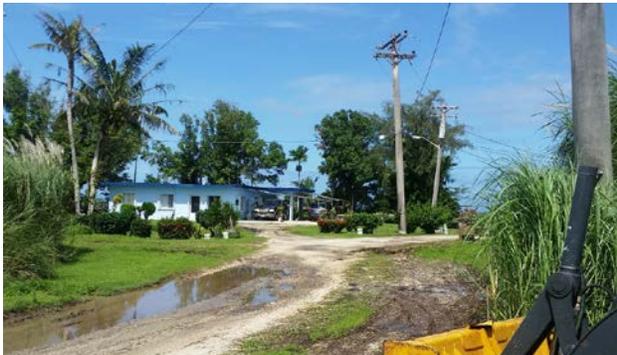
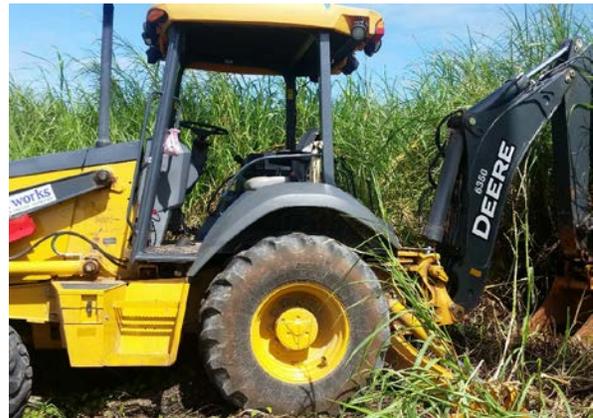
- We observed a backhoe (license plate #6350) parked near a private residence in the Mount Santa Rosa area in Yigo. Images 5 and 6 below show the John Deere backhoe parked by a field of tall grass near a private residence on November 14, 2016.

Image 5: John Deere backhoe (license plate #6350) seen parked unattended near a private residence in Mt. Santa Rosa in Yigo on November 14, 2016.

Image 6: John Deere backhoe – side view (license plate #6350)

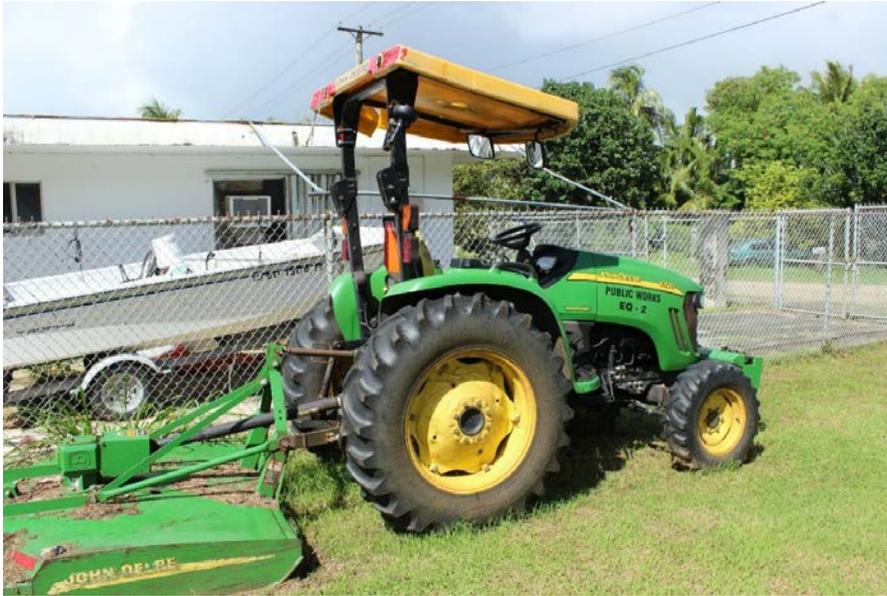
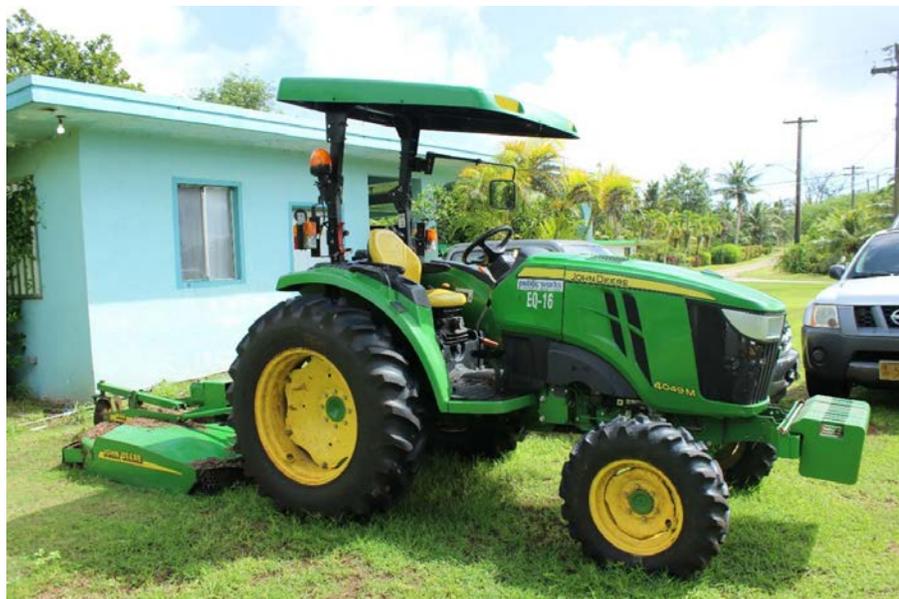
- Images 7 and 8 show two farm tractors (license plate #EQ02-93 and #EQ16-93) at the residences of two DPW employees in Talofofu. According to one of the employees, the farm tractors had been parked at these residences for about two weeks and were used for clearing operations at the request of the village mayor. The EQ02-93 acquired at \$45K and EQ16-93 acquired at \$63K were funded by the Guam Highway Fund and the DOI, respectively.

Image 7: John Deere farm tractor (license plate #EQ02-93) was seen on November 18, 2016 at a DPW employee's residence in Talofofu.

Image 8: John Deere farm tractor (license plate #EQ16-93) was seen on November 18, 2016 at another DPW employee's residence in Talofofu.

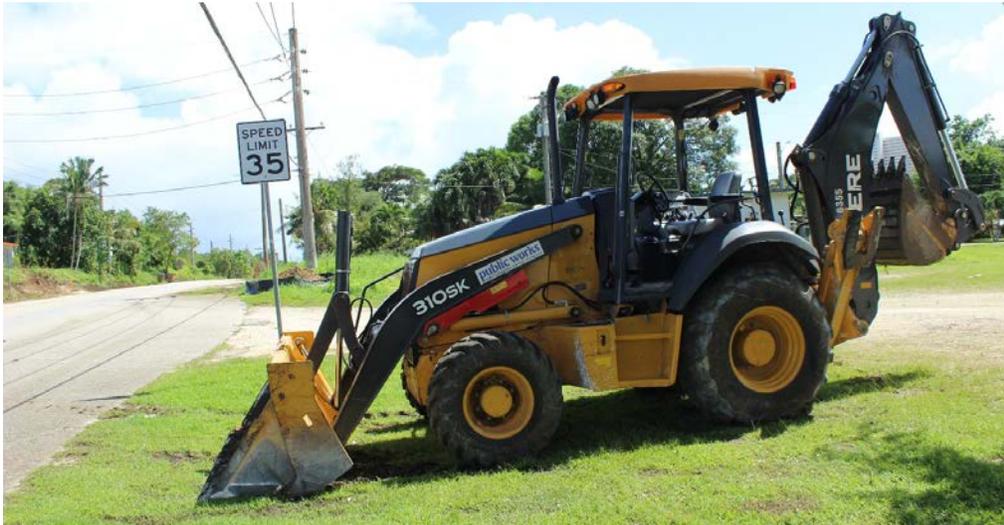
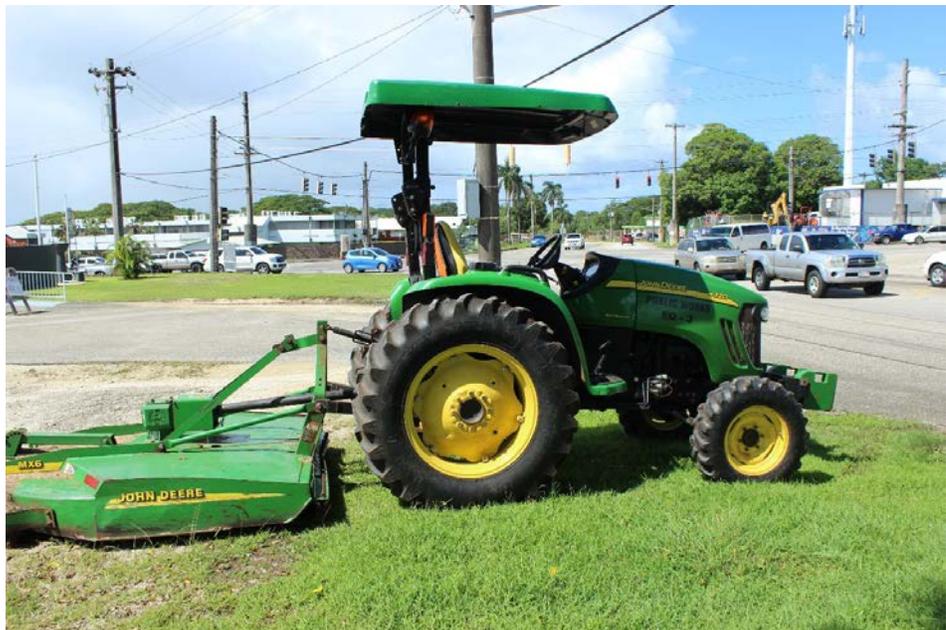
- Images 9 and 10 show a John Deere farm tractor (license plate #EQ03-93) acquired at \$45K and a John Deere backhoe (license plate #6355) acquired at \$121K parked near Santa Teresita Church in Mangilao on November 18 and 19, 2016. The farm tractor and backhoe are funded by the Guam Highway Fund.

Image 9: John Deere backhoe (license plate #6355) seen on November 18 and 19, 2016 near Santa Teresita Church in Mangilao.

Image 10: John Deere farm tractor (license plate #EQ03-93) seen on November 18 and 19, 2016 near Santa Teresita Church in Mangilao.

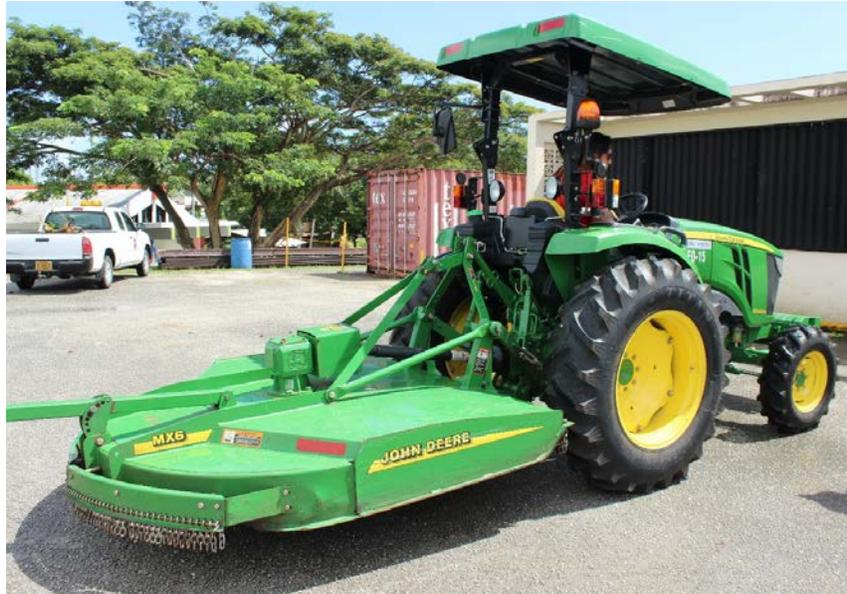
- Image 11 shows a John Deere farm tractor (license plate #EQ15-93) parked at the Barrigada Library. We observed a Barrigada village official operating the farm tractor which was accordingly used in a village clean-up. This equipment is DOI-funded at a cost of \$63K.

Image 11: John Deere farm tractor (license plate #EQ15-93) seen on November 18, 2016 in Barrigada.

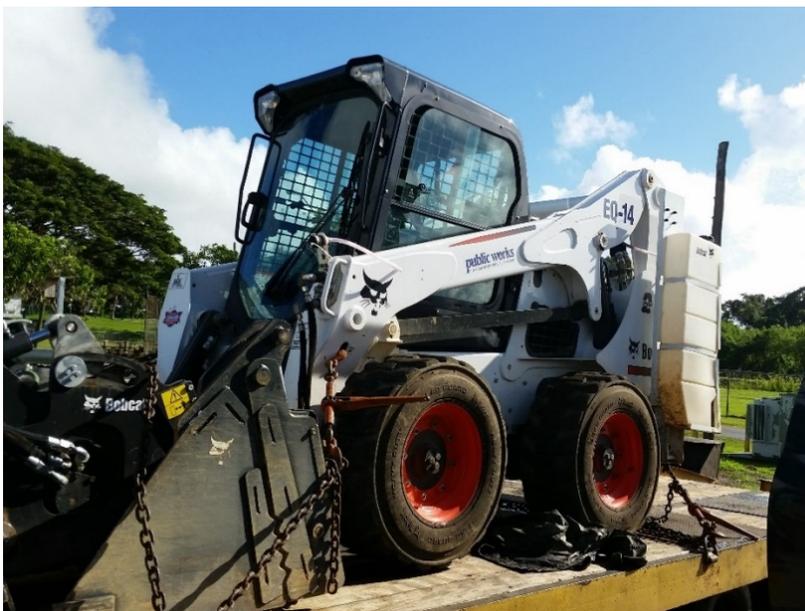
- On November 18, 2016, at the Santa Teresita Church in Mangilao, we observed a 2015 Bobcat skid steer loader (license plate #EQ14-93) loaded on a trailer. As shown in Image 12, the trailer was pulled by a dump truck (license plate #6585) that was driven by a DPW mechanic. We learned from the DPW mechanic that the skid steer loader was being transported to the DPW heavy shop for repairs after breaking down at a private residence in Mangilao.

Image 12: Bobcat skid steer loader (license plate #EQ14-93) was seen on November 18, 2016 at Santa Teresita Church in Mangilao.

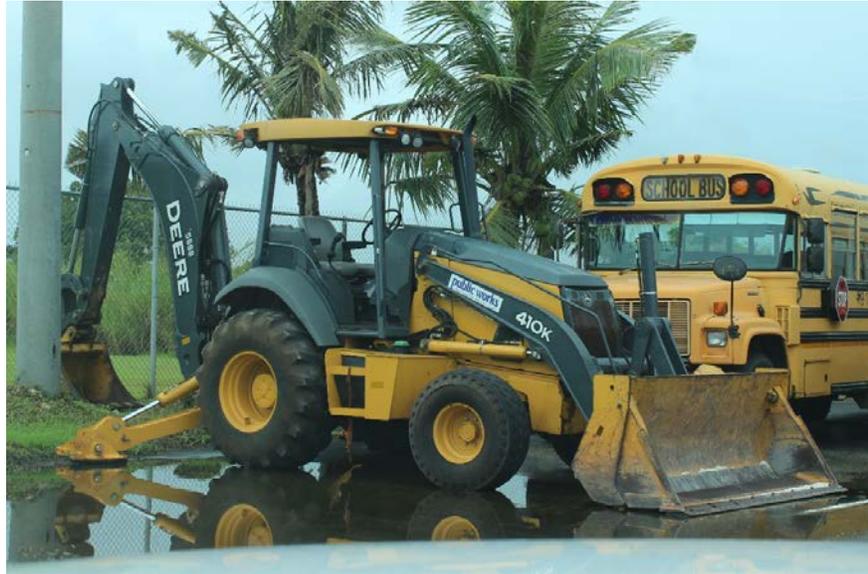
- Image 13 shows a 2014 John Deere backhoe (license plate #5899) parked at the Barrigada Bus Satellite Station on November 3, 2016. We expected the backhoe to be located at the DPW Compound because there were no DJRs assigning it to a certain project. It is alleged that this backhoe was regularly used for personal purposes. The backhoe was purchased in April 2015 for \$129K with Guam Highway Funds.

Image 13: John Deere backhoe with license plate #5899 was seen on November 3, 2016 at the Barrigada Bus Satellite station.

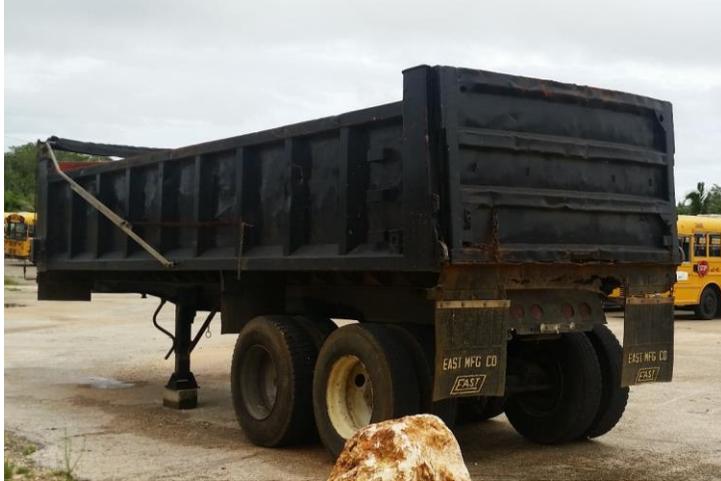
On September 22, 2016, we observed an end dump trailer that was not identified in the DPW inventory listings parked at the Yigo Bus Satellite Station. As shown in Image 14, the end dump trailer did not have a license plate or identifying logo and appeared to have been repainted black from its original red color. An end dump trailer is usually attached to a tractor truck or dump truck to carry and dump heavy loads such as coral and asphalt.

Upon further review, we noted an “end dump” with license plate #3546 was included in the Proposed Vehicles and Equipment for Survey dated August 23, 2006. However, there were no other end dumps surveyed or listed in subsequent survey reports from 2012 to 2015. This end dump has allegedly been used for personal purposes.

Image 14: Unidentifiable end dump was seen on September 22, 2016 at the Yigo Bus Satellite Station.

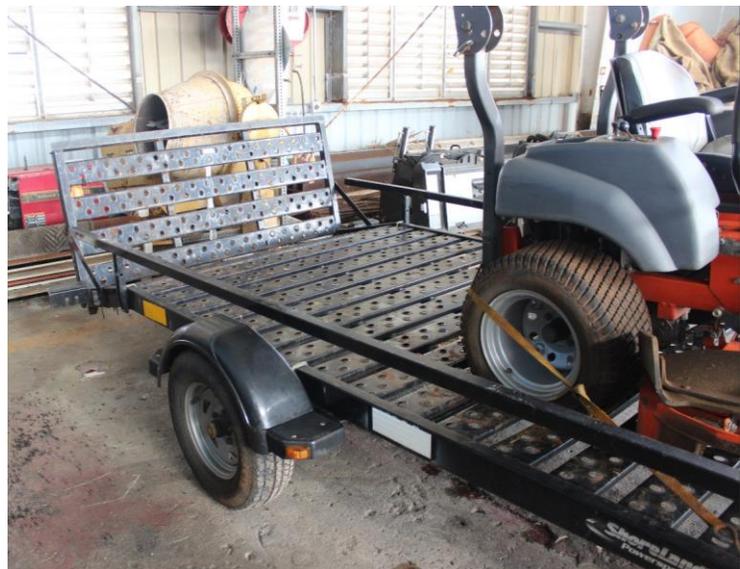
Image 15: Shorelander trailer (license plate #6076) seen on November 14, 2016 at the DPW shop without an attached license plate.

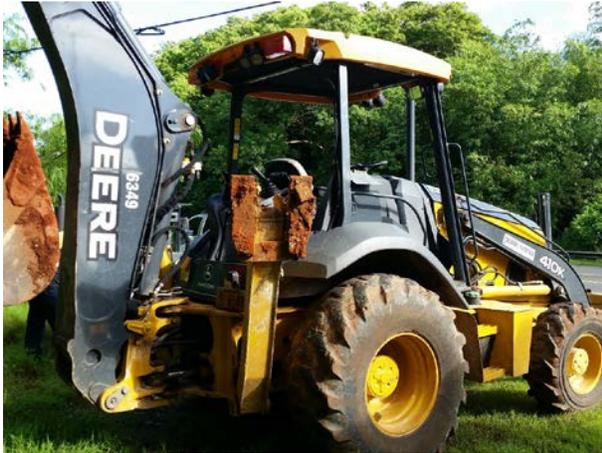
Image 16 shows a DOI-funded backhoe of \$129K (license plate #6349) that was located in Chalan Pago. Image 17 shows a compactor (license plate #EQ07-93) and Image 18 shows another backhoe (license plate #6355) that were both located in Mangilao.

Image 16: John Deere backhoe (license plate #6349) seen on November 18, 2016 parked by Route 4 in Chalan Pago.

We recommend DPW management develop an MOU with the Mayors Council to assign responsibilities and hold parties accountable for heavy equipment usage.

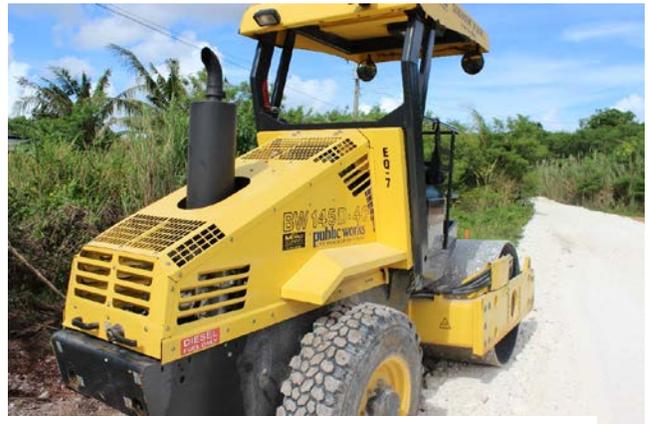
Image 17: Bomag compactor roller (license plate #EQ07-93) seen on November 14, 2016 in Mangilao.

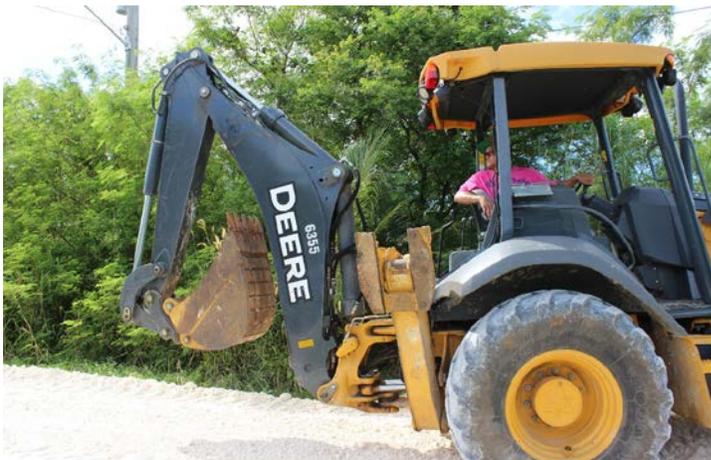
Image 18: John Deere backhoe (license plate #6355) seen on November 14, 2016 in Mangilao.

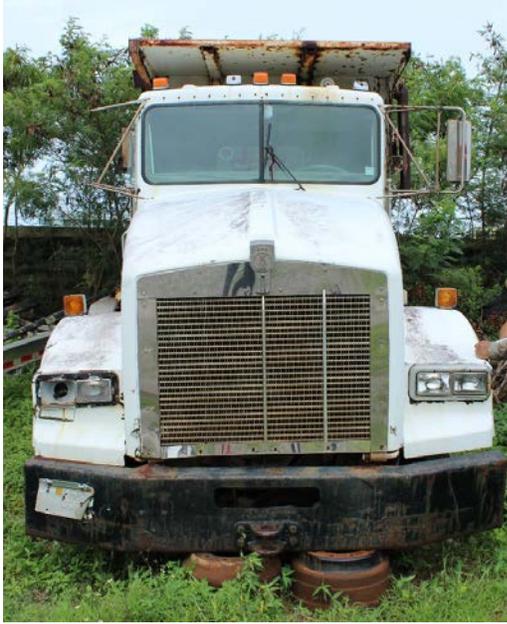
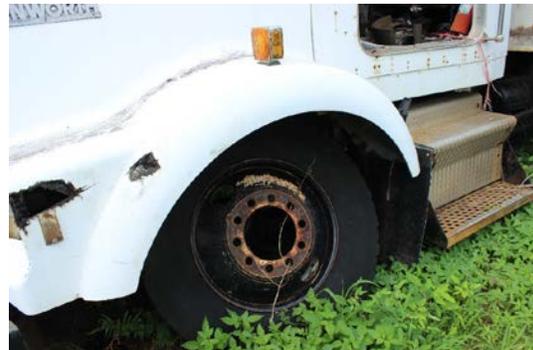
As an example, in Images 19 and 20, we observed a 1992 dump truck (license plate #93-0639) with its front wheel axle removed and its tire concealing the removed part. It is alleged that the axle was removed and given to a DPW employee for personal use. The dump truck was not among the record of surveyed vehicles and equipment. The present replacement value of a wheel axle is approximately \$4K.

Image 19: Dump truck - front view (license plate #93-0639) seen sitting on wheel drums in order to keep it off the ground on September 26, 2016 at the DPW Heavy Shop.

Image 20: Dump truck (license plate #93-0639) seen on September 26, 2016 at the DPW Heavy Shop with missing front axle.

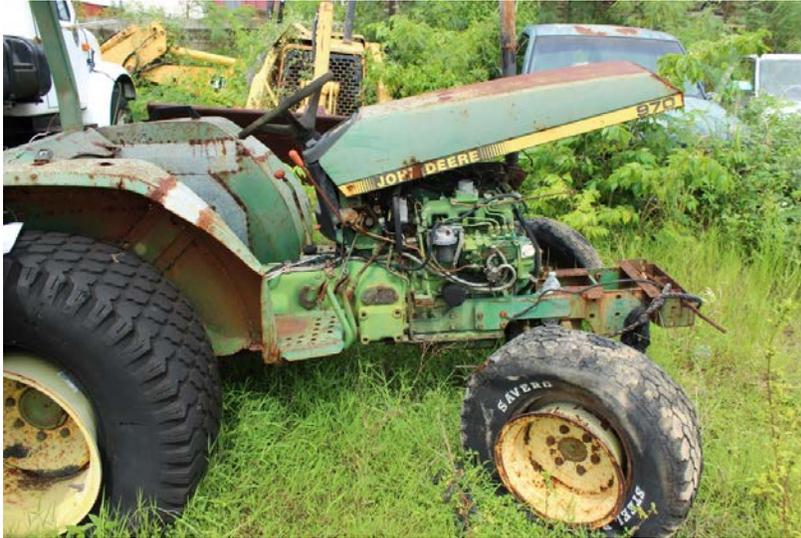
- Image 21 shows a deteriorated and cannibalized John Deere Farm Tractor (license plate #93-622/4444) located on the DPW compound on November 4, 2016. SRO #856 was prepared and processed for this cannibalized farm tractor on June 10, 2015 for a general checkup. A Heavy Shop mechanic drew 28 parts totaling \$2K based on this SRO. The tractor was not included in the DPW inventory listing as of February 1, 2016.

Image 21: Deteriorated John Deere farm tractor (license plate #93-622/4444) seen on November 4, 2016 at the DPW lot.

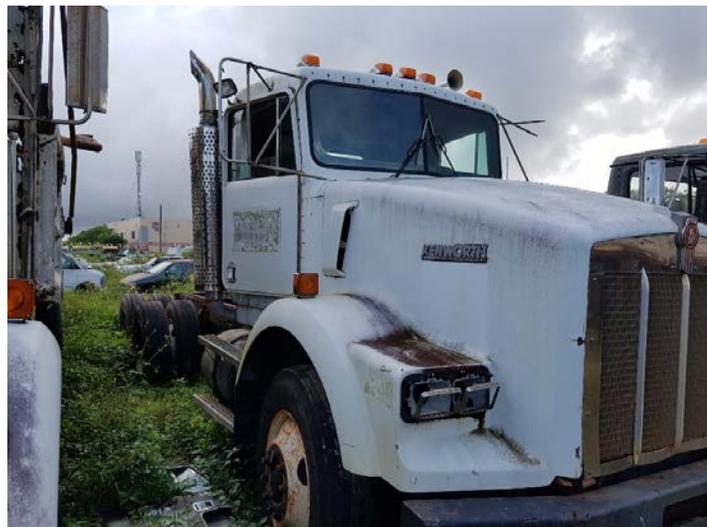
- Image 22 shows a deteriorated and cannibalized Kenworth Dump Truck (license plate #613) located on the DPW compound on November 4, 2016. This truck's maintenance card indicated that in October 2014, the dump truck was cannibalized to supply parts to another dump truck (license plate #612). The parts taken were not noted on the maintenance card of #613. We also noted parts valued at \$2K were issued to the dump truck via six SROs in FY 2014 and FY 2015.

Image 22: Deteriorated Kenworth dump truck (license plate #613) seen on November 4, 2016 at the DPW lot.

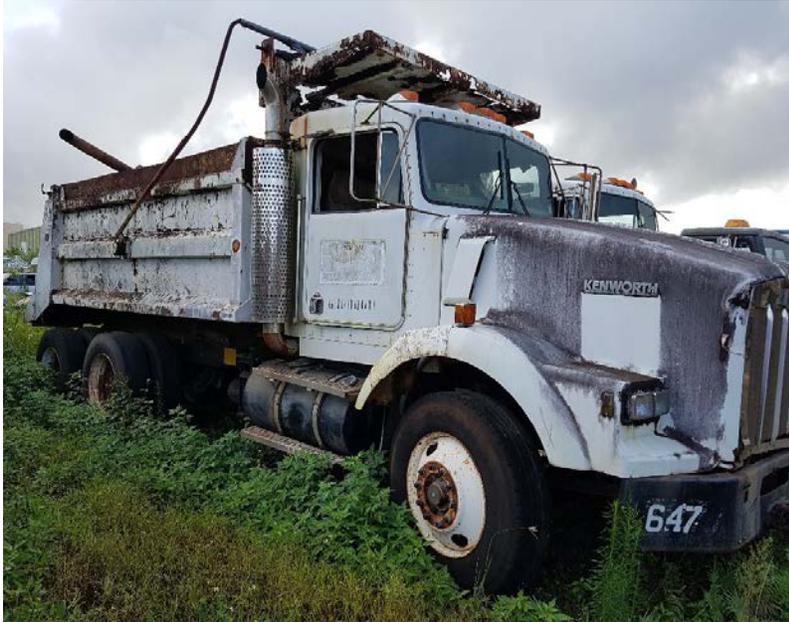
- Image 23 shows a deteriorated and cannibalized Kenworth dump truck (license plate #93-647/6499) located on the DPW compound on November 4, 2016. This truck is not included in DPW's inventory listing as of Feb 1, 2016. The truck's maintenance card indicated per SRO #0423, that a safety inspection was done. Ten parts totaling \$2K were also requested and issued in February 2014 and May 2014. The last maintenance card entry was in February 2014.

Image 23: Deteriorated Kenworth dump truck (license plate #93-647/6499) seen on November 4, 2016 at the DPW lot.

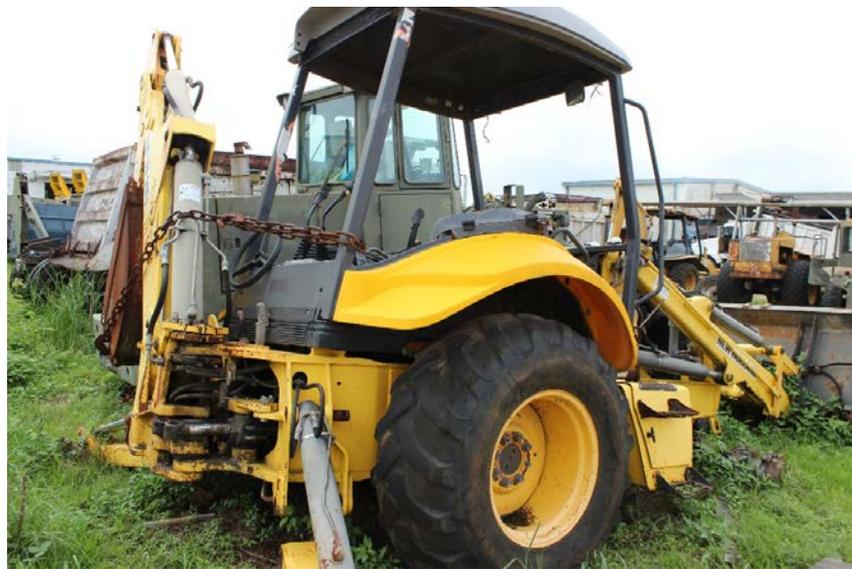
- Image 24 shows a deteriorated and cannibalized New Holland backhoe (license plate #4706) located on the DPW compound on November 4, 2016. The only information recorded in this backhoe's maintenance card is SRO #15-973 for a hydraulic leak in July 2015. However, we found SRO #776 and #366 issued nine parts (filter fuel, filter oil, filter air, filter hydrants, etc.) totaling \$600 in FY 2014 and FY 2016.

Image 24: Deteriorated New Holland backhoe (license plate # 4706) seen on November 4, 2016 at the DPW lot.

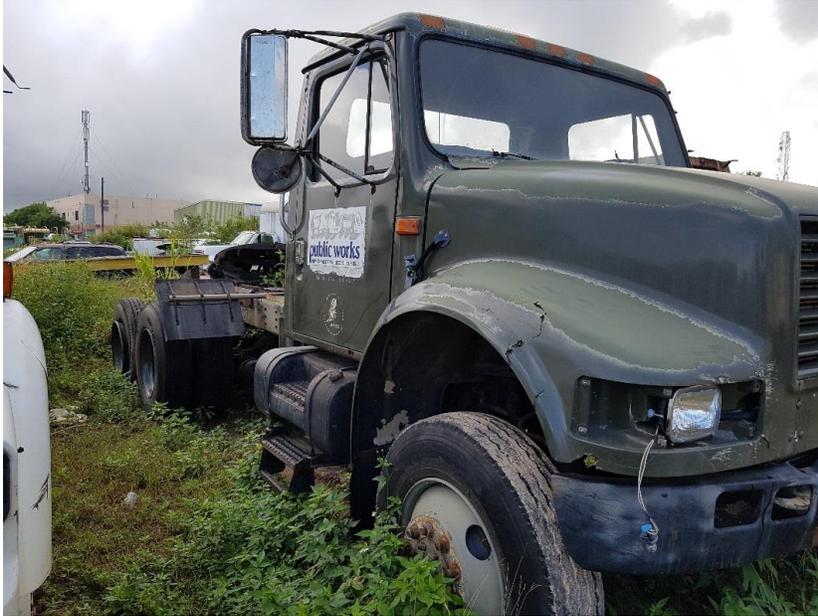
- Image 25 shows a deteriorated and cannibalized 1992 International tractor truck (license plate #153) located on the DPW compound on November 4, 2016. During FY 2014 and FY 2015, three SROs issued 7 parts (mud guards, light hoppers, flex hose, and oil) amounting to \$200 to this tractor truck.

Image 25: Deteriorated International tractor truck (license plate #153) seen on November 4, 2016 at the DPW lot.

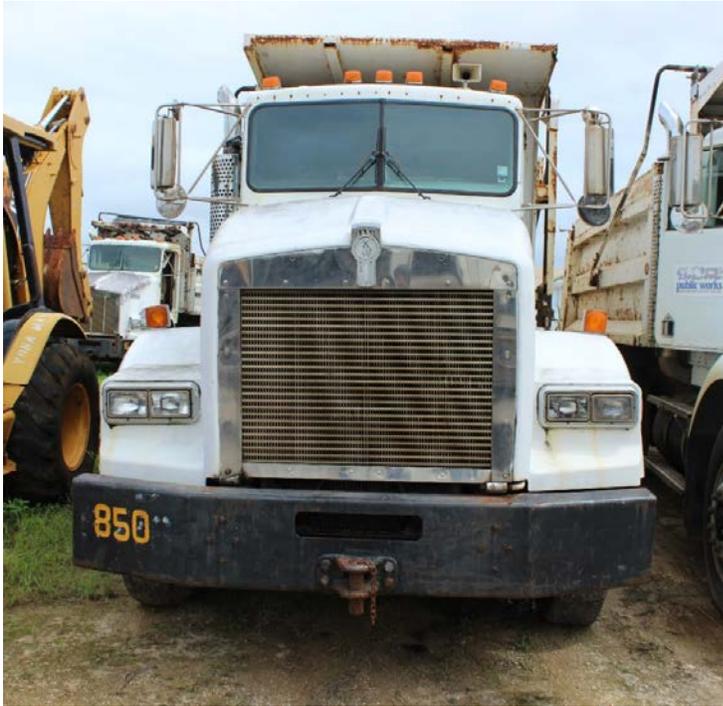
- Image 26 shows a Kenworth T-800 dump truck (license plate #850) at the DPW Heavy Shop on November 4, 2016. The dump truck was awaiting transmission repairs as indicated in SRO #854 dated June 9, 2015. However, 2 days later on June 11, 2015, a radiator assembly costing \$2K was issued by the Supply Warehouse. It is alleged the radiator was given to a DPW employee for personal purposes. Our inspection could only see the top of the radiator, which appeared to be in good condition. Therefore, we could not determine why a radiator was requested for this dump truck. We also found that the dump truck's maintenance card indicated SRO #165 for a tire dated December 2, 2016; however, the issuing report showed 22 parts irrelevant to a tire (cylinder power steering, alarm, coolant, dryer air, and valve "trac") totaling \$3K. Subsequent issuances using the same SRO were not recorded in the maintenance card.

Image 26: Kenworth dump truck (license plate #850) seen on November 4, 2016 at the DPW Heavy Shop awaiting repairs.

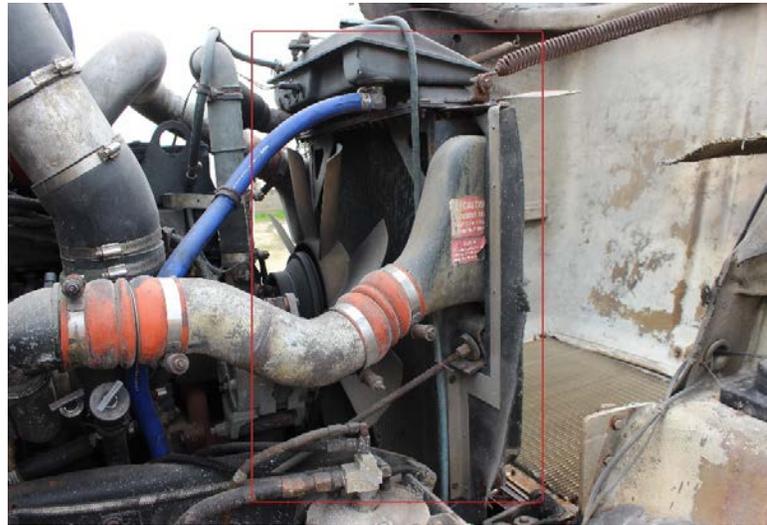
Image 27: Radiator on a Kenworth dump truck (license plate #850) seen on November 15, 2016.

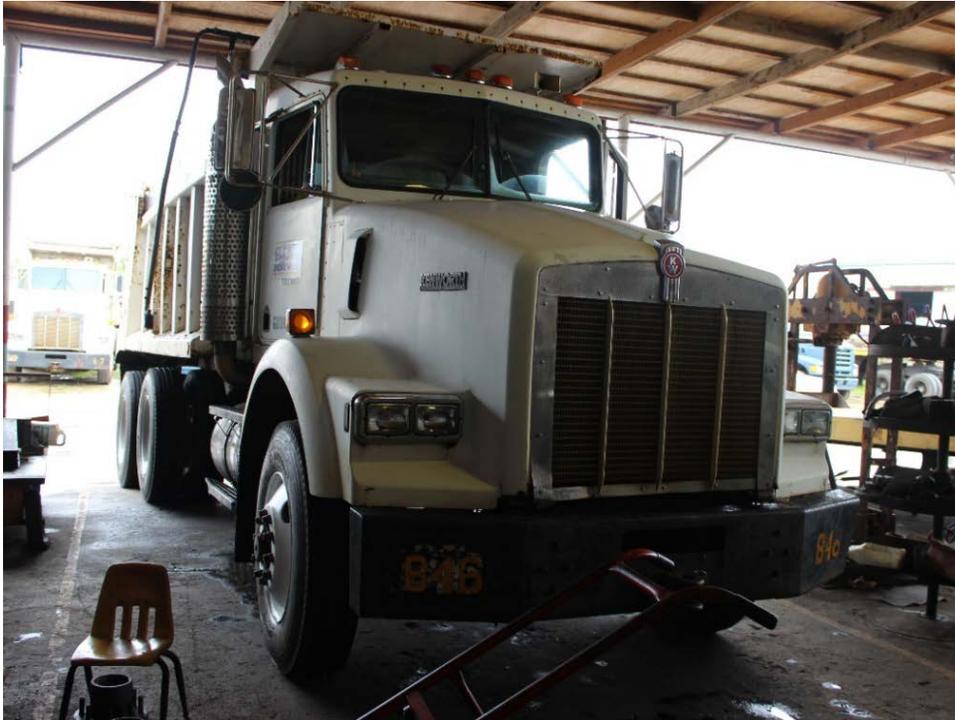
- Image 28 shows a Kenworth dump truck (license plate #846) at the DPW Heavy Shop on November 4, 2016 awaiting transmission repairs. The dump truck's maintenance card indicated "tire" per SRO #16-164 dated December 2, 2015. However, we found that 24 unrelated parts (cylinder power steering, alarm, nozzle injector, etc.) totaling \$6K were issued based on this SRO. Image 29 shows our sample of the spring multi-leaf installed in May 2016 per SRO#16-615, which was irrelevant to the cooling system defect.

Image 28: Kenworth dump truck (license plate #846) seen on November 4, 2016 at the DPW Heavy Shop awaiting repairs.

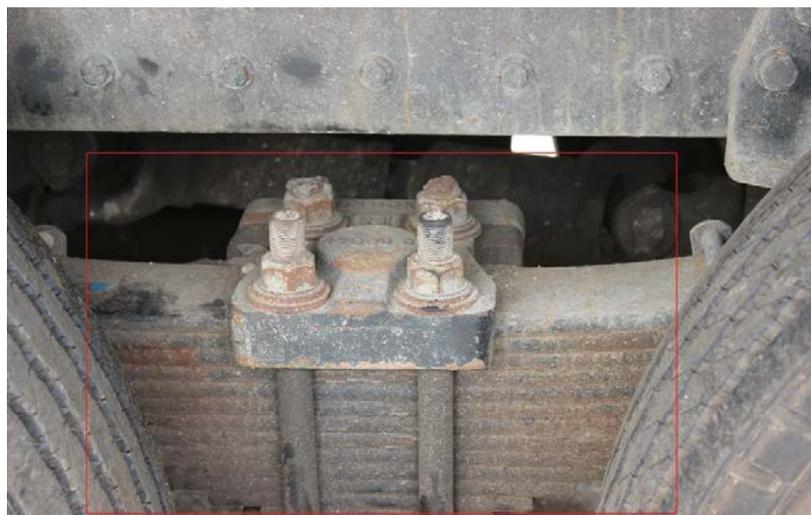
Image 29: Spring multi-leaf on Kenworth dump truck (license plate #846) seen on November 15, 2016.

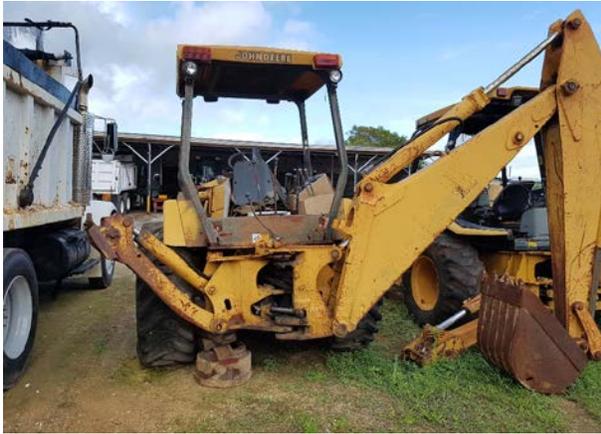
- Image 30 shows a John Deere Backhoe (license plate #630) at the DPW Heavy Shop on November 4, 2016 awaiting an engine replacement. The backhoe was not in DPW's February 1, 2016 inventory listing. The last entry on the backhoe's maintenance card was on October 1, 2014, for an engine defect. However, per SRO #013, in FY 2015 and FY 2016, 222 parts (radiator, connector, nozzle injector, etc.) totaling \$3K were issued to this backhoe. Image 31 shows our sample of a rusty turbo located on the floor of the backhoe that should have been installed in January 2015 per the SRO.

Image 30: John Deere backhoe (license plate #630) seen on November 4, 2016 at the DPW Heavy Shop awaiting repairs.

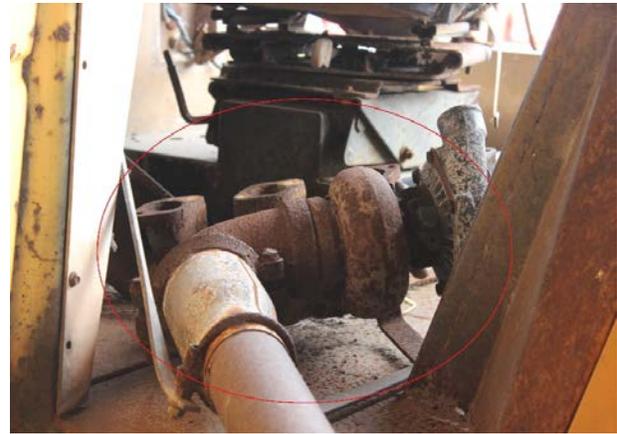
Image 31: Turbo on John Deere backhoe (license plate #630) seen on November 15, 2016.

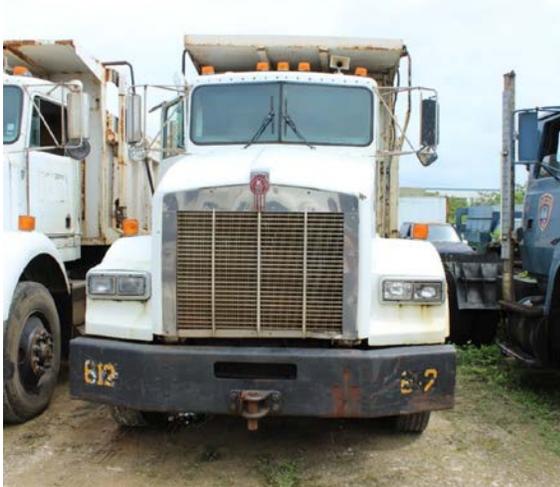
- Image 32 shows a Kenworth dump truck (license plate #612) at the DPW Heavy Shop on November 4, 2016 awaiting repairs for a walk beam. Image 33 shows a rusty motor canvas installed in December 2015, less than a year prior to our physical inspection.

Image 32: Kenworth dump truck (license plate #612) seen on November 4, 2016 at the DPW Heavy Shop awaiting repairs.

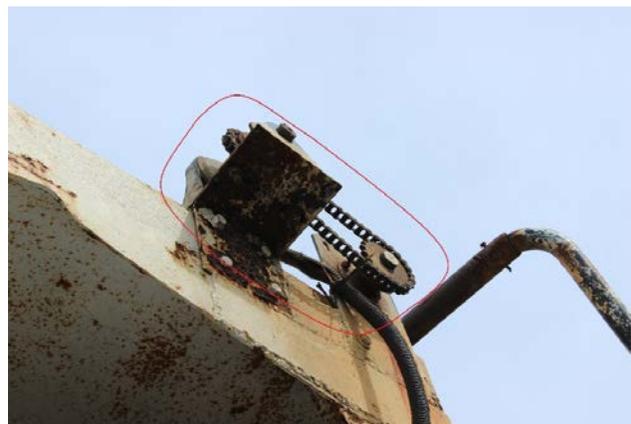
Image 33: Motor canvas on dump truck (license plate #612) seen on November 15, 2016.

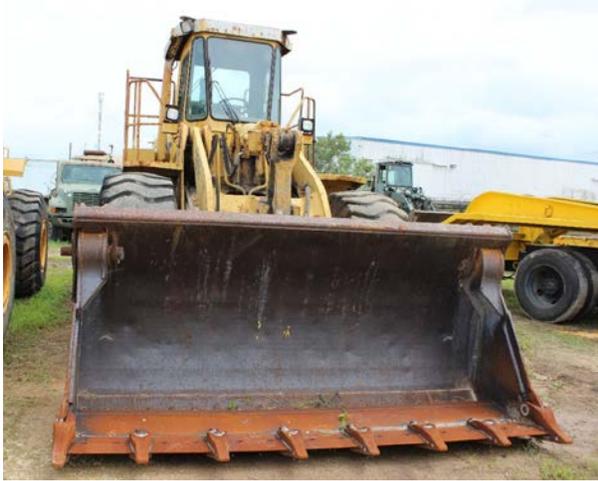
- Images 34 and 35 shows a Caterpillar payloader (license plate #3806) at the DPW Heavy Shop in November 2016 awaiting radiator repairs. This payloader has been idle since 2014.

Image 34: Caterpillar payloader (license plate #3806) seen on November 4, 2016 at the DPW Heavy Shop awaiting repairs.

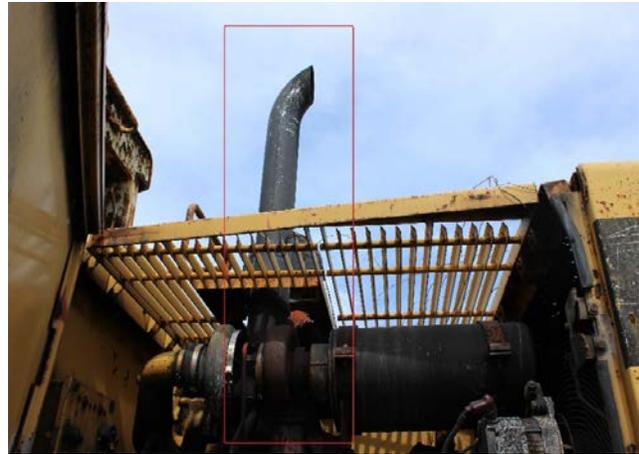
Image 35: Rusty pipe exhaust issued to a Caterpillar payloader in January 2015 (license plate #3806) and seen on November 15, 2016, although SRO states starter, electrical, muffler, and ignition defects.

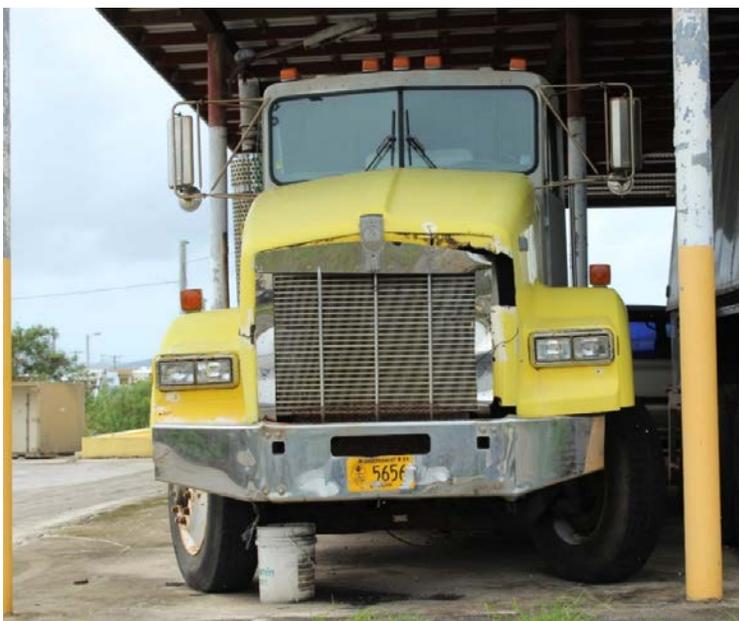
- Images 36 and 37 shows a Kenworth dump truck (license plate #5656) at the DPW Heavy Shop on November 4, 2016 awaiting general reconditioning work.

Image 36: Kenworth dump truck (license plate #5656) seen on November 4, 2016 at the DPW Heavy Shop awaiting repairs.

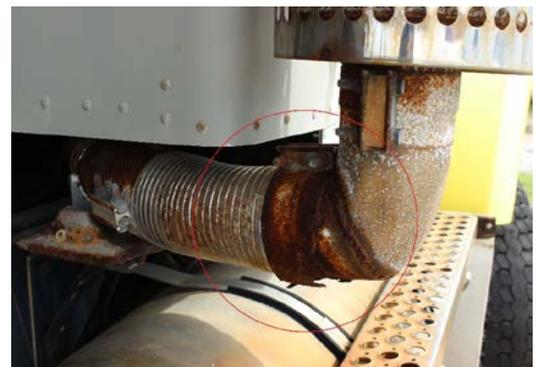
Image 37: Old and rusty bracket exhaust on Kenworth dump truck (license plate #5656) installed May 2015 and seen on November 15, 2016.

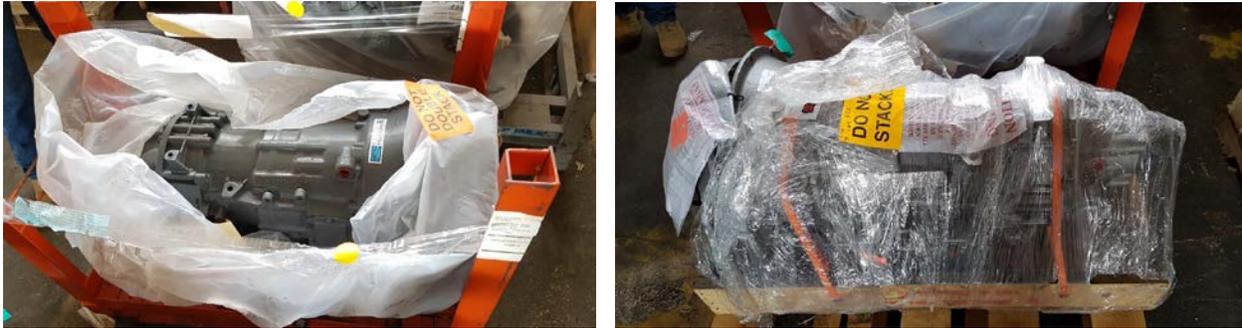
As shown in Image 38, during our physical inspection on February 3, 2017, we found the parts in the Supply Warehouse labeled for dump truck with license plate #850. Per the truck's maintenance card, this has been idle since 2014 for various defects including transmission replacement.

Image 38: Two transmissions seen on February 3, 2017 at the DPW supply warehouse for one dump truck (license plate #850).
